Post-test Examination of a Pool Boiler Receiver

Robert L. Dreshfield, Thomas J. Moore,
and Paul A. Bartolotta
National Aeronautics and Space Administration
Lewis Research Center

April 1992

POST-TEST EXAMINATION OF A SUBSCALE POOL BOILER TEST APPARATUS

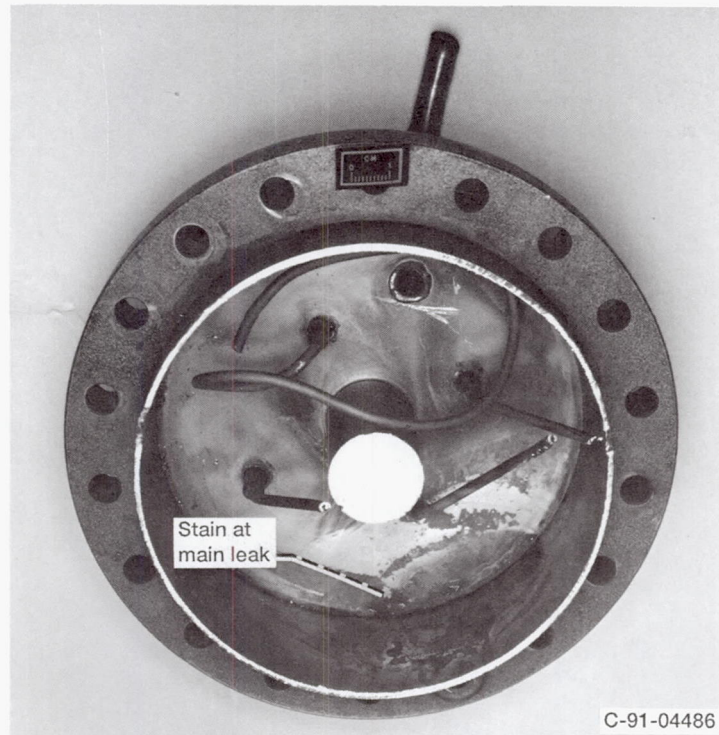
The type 316 stainless steel condenser was cut from the pool boiler just below the flange so that the failure region could be examined. The large stain on the underside of the flange, shown in figure 2, pinpoints the location of the main leak. The weld between the cylindrical condenser and the flange is shown in the

Figure 2.—Cross section of 12.7 cm O.D. condenser showing underside of the flange and a stain at the main leak location. All components are made of Type 316 stainless steel.

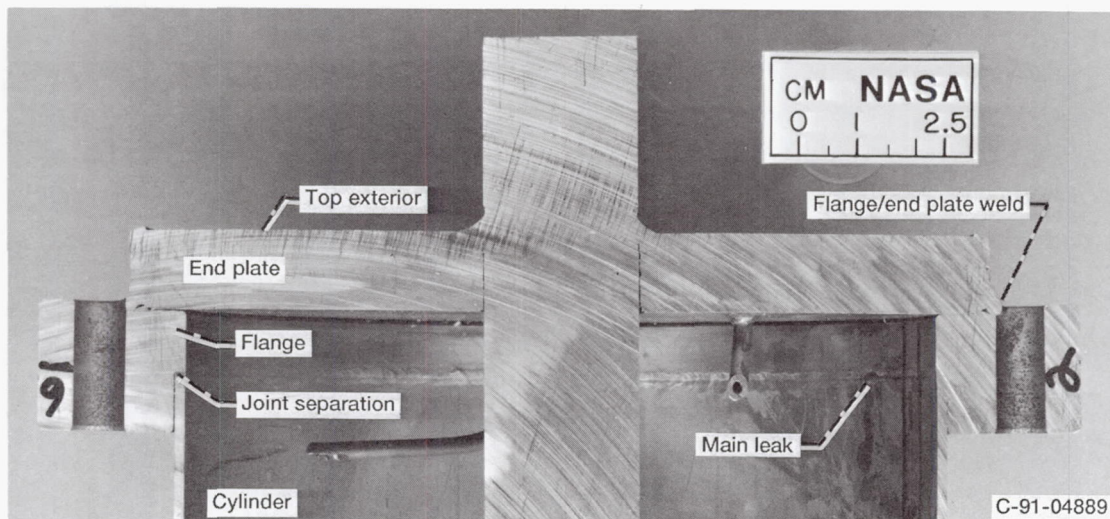
longitudinal section in figure 3. Regions of joint separation at the main leak and on the opposite side are indicated. A close up view of the 15 mm long main leak region in figure 4 shows that the leak was located in the weld metal. Cross section A-A from figure 4 is shown in figure 5(a). The joint penetration was only 28 percent. If the penetration had been 100 percent, the weld would have been more than three times as strong and probably would not have failed. A region where a crack in the weld had not extended completely through the wall is shown in figure 5(b). Here, the joint penetration was 38 percent. It is evident that the weld joint failure was a result of inadequate joint penetration (which could have been detected by radiography). The small cross section of the weld simply could not support the deadweight of the structure and the weld failed by creep rupture during the experiment. There was no evidence that corrosion was a factor in this weld joint failure.

Figure 3.—Cross section at the top of the condenser showing the main leak region and joint separation at the weld between the condenser cylinder and the flange. The material used for all components was Type 316 stainless steel.

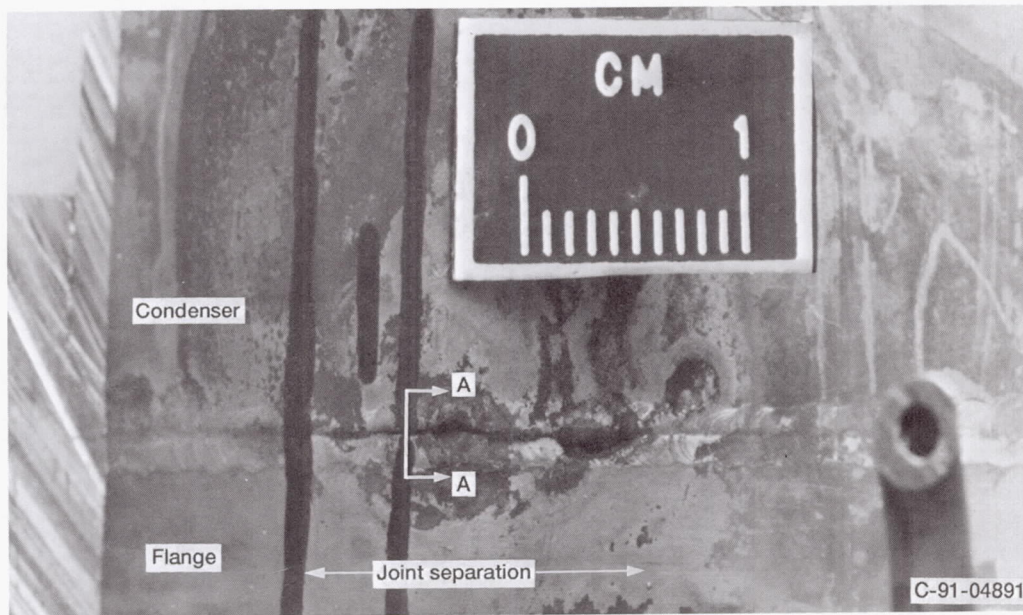
Figure 4.—Main leak region at the weld between the condenser cylinder and the flange.

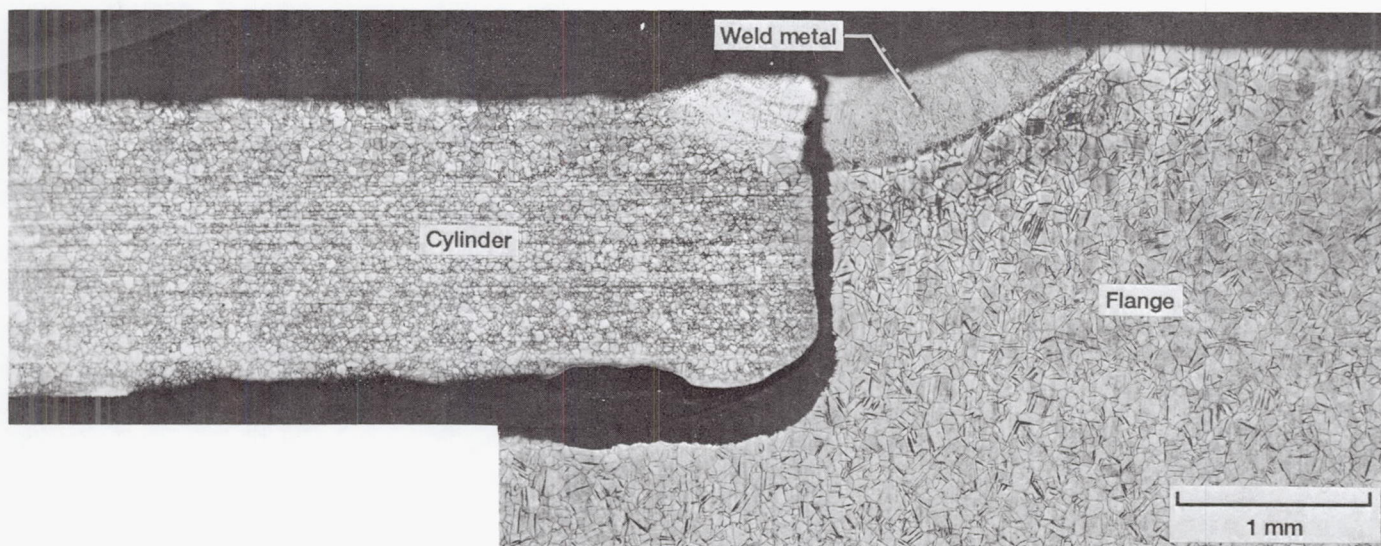
1. The leaks observed by Thermocore personnel in the type 316 stainless steel condenser appear to be the result of a welding technique which produced welds with only 28 to 38 percent penetration. It is believed that full penetration welds in the condenser would have survived the test conditions as no corrosion effects were noted in the failed region of the condenser.

(a) Complete separation of joint at the main leak where the joint penetration was 28%.

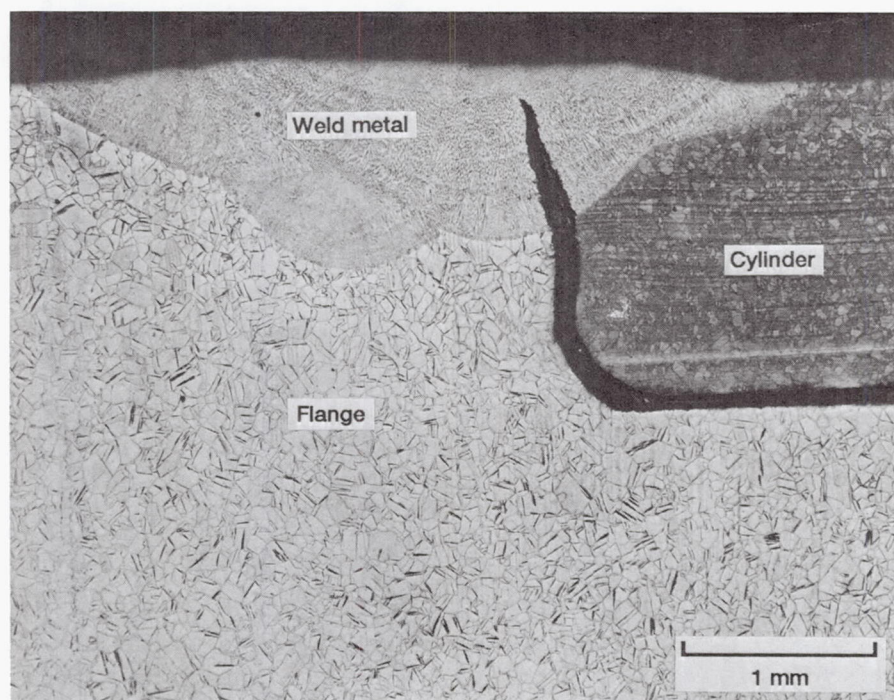
(b) Region where the weld failure is incomplete. Joint penetration was 38%.

Figure 5.—Cylinder/flange weld joint in Type 316 stainless steel showing complete failure at the main leak and nearly complete weld failure at another location.

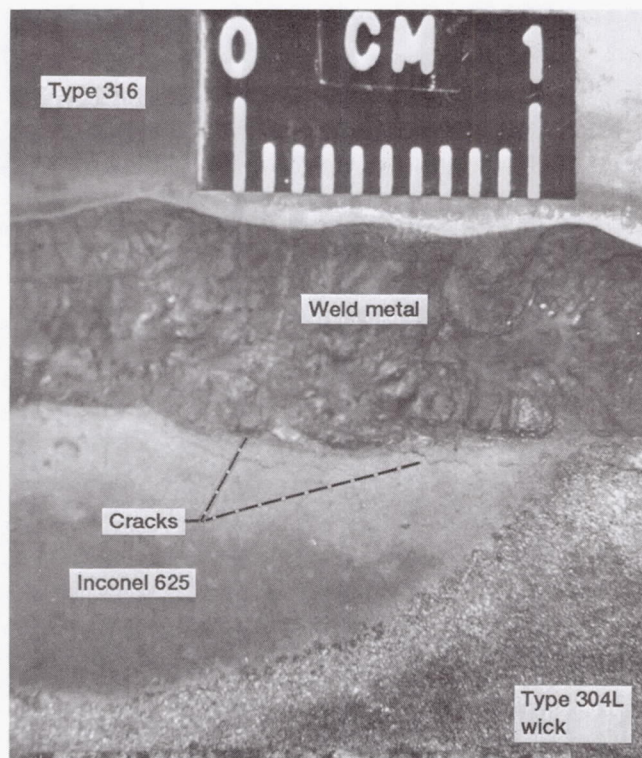
The butt joint, between type 316 stainless steel and Inconel 625 tubing, (fig. 1) was included in this investigation for general information purposes. Both tubes were 76.5 mm diameter with a 1.4 mm wall thickness. A type 304L stainless steel sintered wick was present at the inner surface of the Inconel 625 tubing, just below the weld joint. Unanticipated cracking was discovered in the heat affected zone of the Inconel 625 material at the weld root (fig. 6). This internal cracking was parallel to the weld and did not follow the wick pattern. The photomicrograph in figure 7(a) shows that the cracking proceeded from the inner surface more than halfway through the wall of the Inconel 625 tube. As shown in figure 7(b), both the main crack and a secondary crack were intergranular in nature. As also can be observed in figure 7(b), a thin band of material is present along the walls of the main crack. This band was examined further in a scanning electron microscope. The back-scatter image in figure 8 shows the thin band with porosity under the band. The porosity probably resulted from the Kirkendall effect. Standardless x-ray energy dispersive spectra analysis revealed that the material within the band matched the Inconel 625 base metal spectra except for the absence of Fe. The nominal analysis for Fe in Inconel 625 is 2.5 wt %. No oxygen was detected (<5 wt %) within the band which discounts the presence of oxides. This iron depleted region suggests that the NaK may have corroded the Inconel 625 adjacent to the crack (this may be crevice corrosion). However it is also plausible that the Inconel 625 was oxidized when the crack initially formed and the NaK subsequently reduced the oxide layer, preferentially dissolving the iron in the oxide.

Figure 6.—Weld root (interior) surface of dissimilar metal weld joint between Type 316 stainless steel and Inconel 625 tubing. Cracks are present in the heat affected zone of the Inconel 625 material.

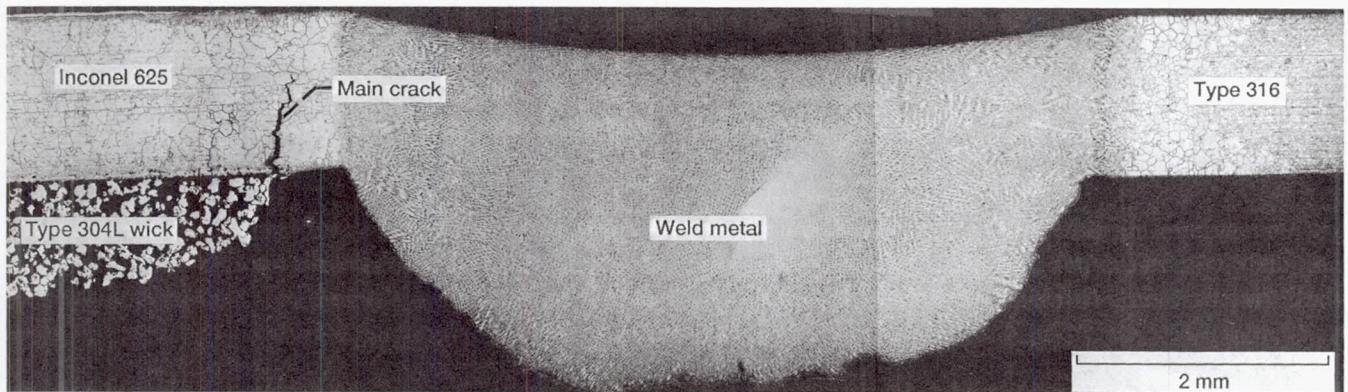
Further examination of figure 7(a) shows that the weld width is about 4-1/2 times the thickness of the tubing. In other locations, the weld was as much as 6 times as wide as the tubing. The width of the weld and the concave face are evidence that excessive heat input was used. Thus, overheating during welding rather than a corrosion effect is the most likely cause of the cracking and the cracks probably were present before the boiler was operated. It is likely that radiographic examination would have shown this defect.

3. Cracking was observed in the Inconel 625 weld heat affected zone of the weld joining the type 316 stainless steel condenser to the boiler. It is believed that excessive heat input during welding caused the crack which initiated at the internal surface of the pipe.

(a) Cross section of weld joint showing very wide weld and crack in the Inconel 625 heat affected zone.

6. Nondestructive examination of welds by radiographic methods are recommended for future hardware.

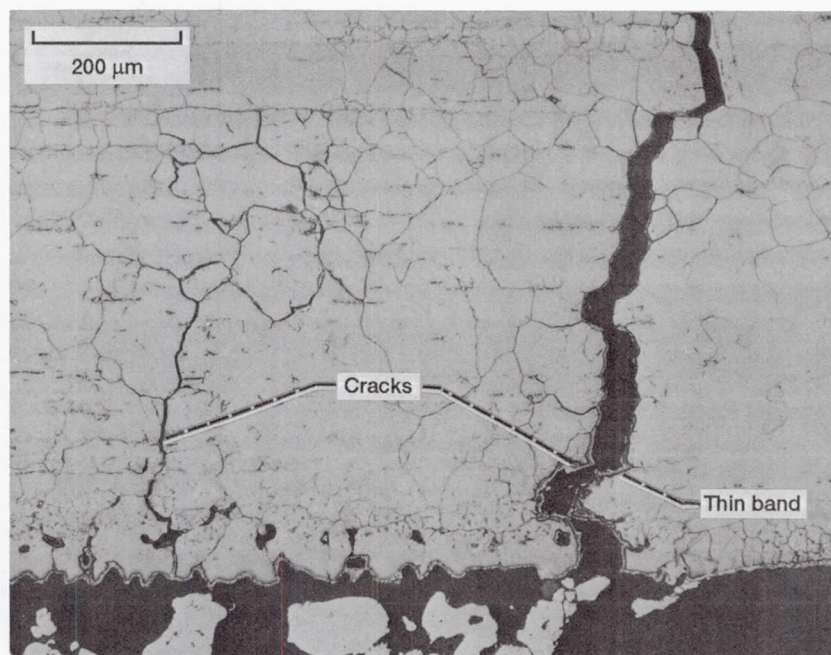
(b) Main and secondary intergranular cracks in the Inconel 625 base metal.

Figure 7.—Dissimilar metal weld between Type 316 stainless steel and Inconel 625 tubing showing intergranular cracks at the inner surface of the Inconel 625 base metal heat affected zone. 10% chromic acid etch.

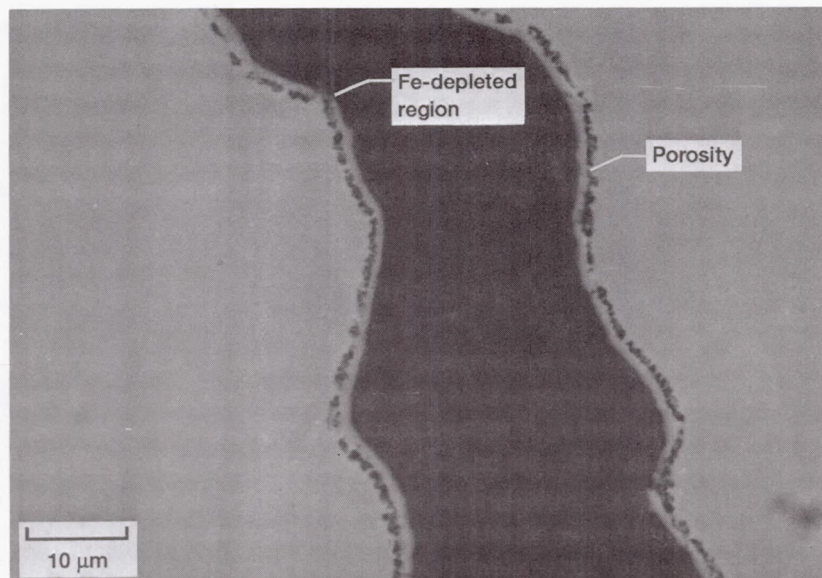
4. The heat affected zone crack in the Inconel 625 showed evidence of corrosion in that an iron depletion zone and porosity were observed below the surface of the crack. It is not known if the iron in the Inconel 625 was directly attacked by the NaK in the crack, or if the crack had been oxidized when it formed and the iron dissolved when the oxide was subsequently reduced by the NaK. If Inconel 625 is to be considered for NaK service in the future, it is recommended that additional compatibility studies be performed.

Figure 8.—Backscattered electron image at crack in Inconel 625 base metal. An iron-depleted band is present at the walls of the crack with a porous zone under the band.

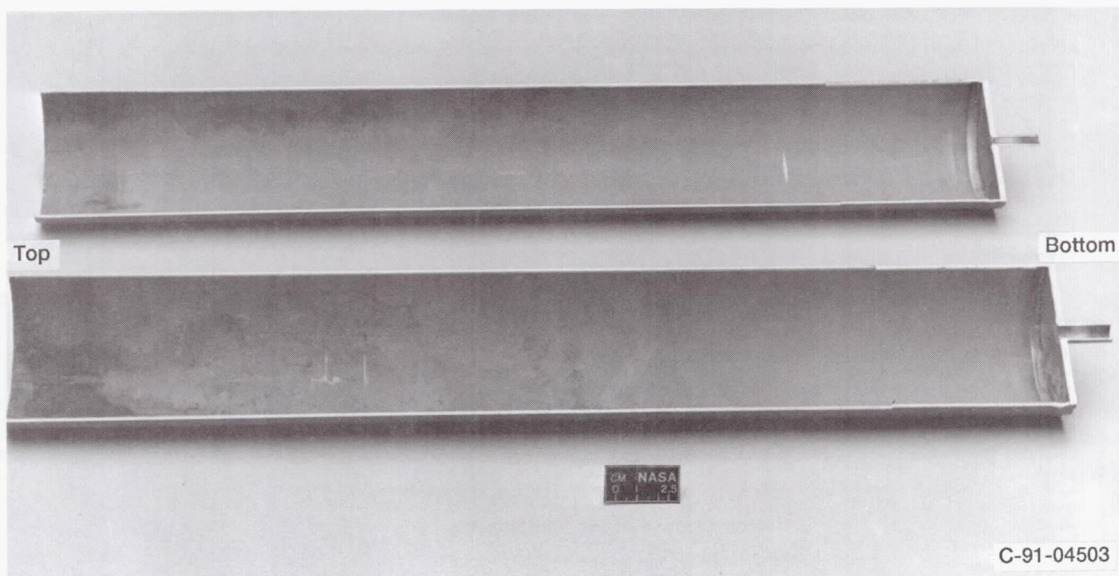
The subscale boiler section was initially sectioned longitudinally. The interior surface is shown in figure 9. The interior surfaces generally appeared to show little effect of exposure to the NaK. There was a slight discolored region toward the top of the boiler which was a rust color.

Samples of the rust colored deposits were examined by both scanning electron microscopy and x-ray diffraction. Only Fe, Cr, and Ni were detected, the crystal structure being face-centered cubic. That analysis indicates the material is the matrix of the type 304L stainless steel wick material. The colored material is assumed to be too thin to detect by the analytical methods applied.

Figure 9.—Longitudinal section of boiler showing slight discoloration near top.

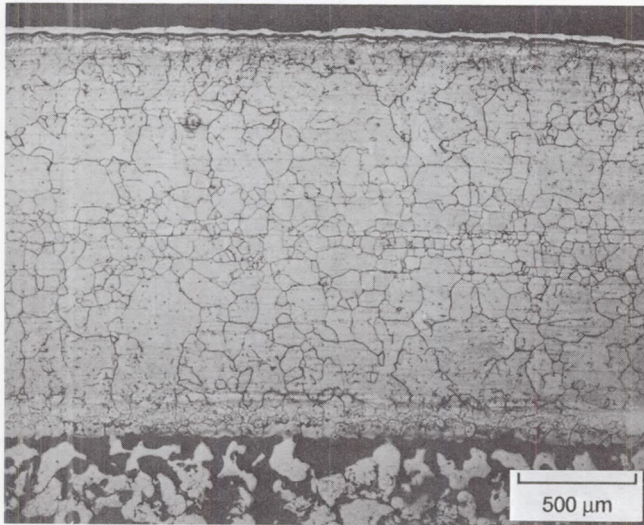
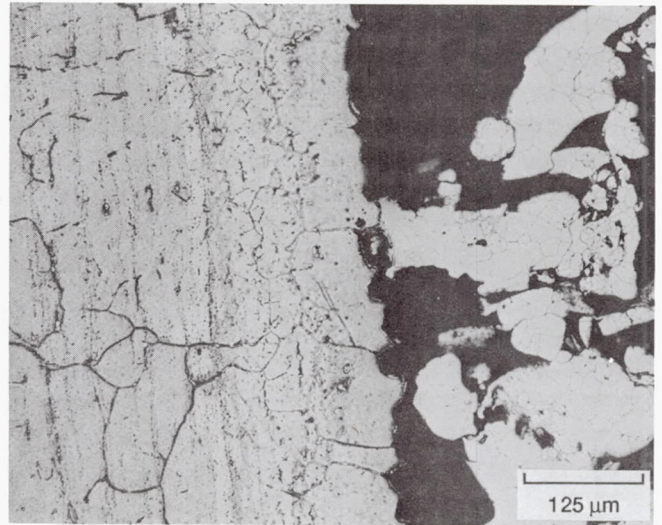
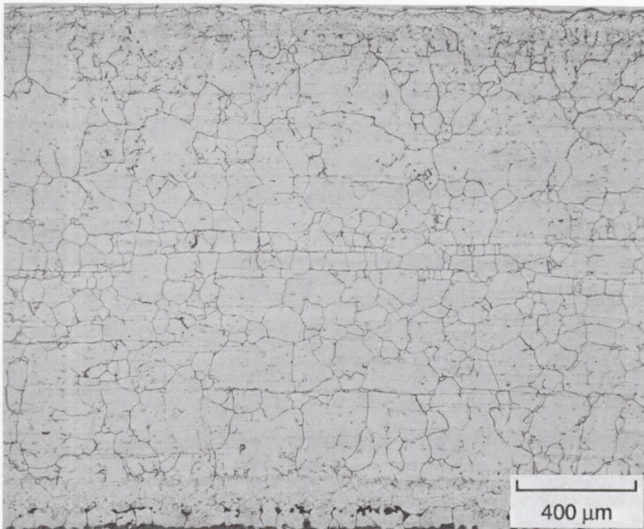
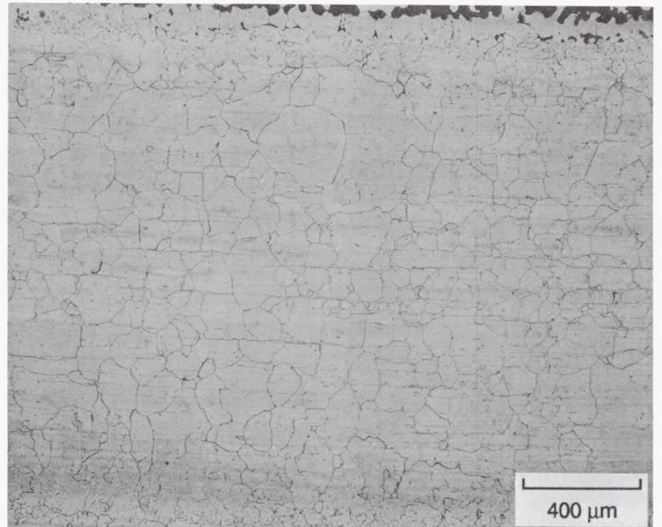
Metallographic examination of samples from the three different elevations showed no correlation of the microstructure with the elevation of the sample. Representative photomicrographs are shown in figure 11. There is no evidence of NaK attack on either the wick or the substrate. A light etching zone can be seen below the type 304L wick. This is believed to be a nickel rich zone resulting from the wick fabrication process.

Figure 11.—Selected photomicrographs of Inconel 625 boiler interface.
